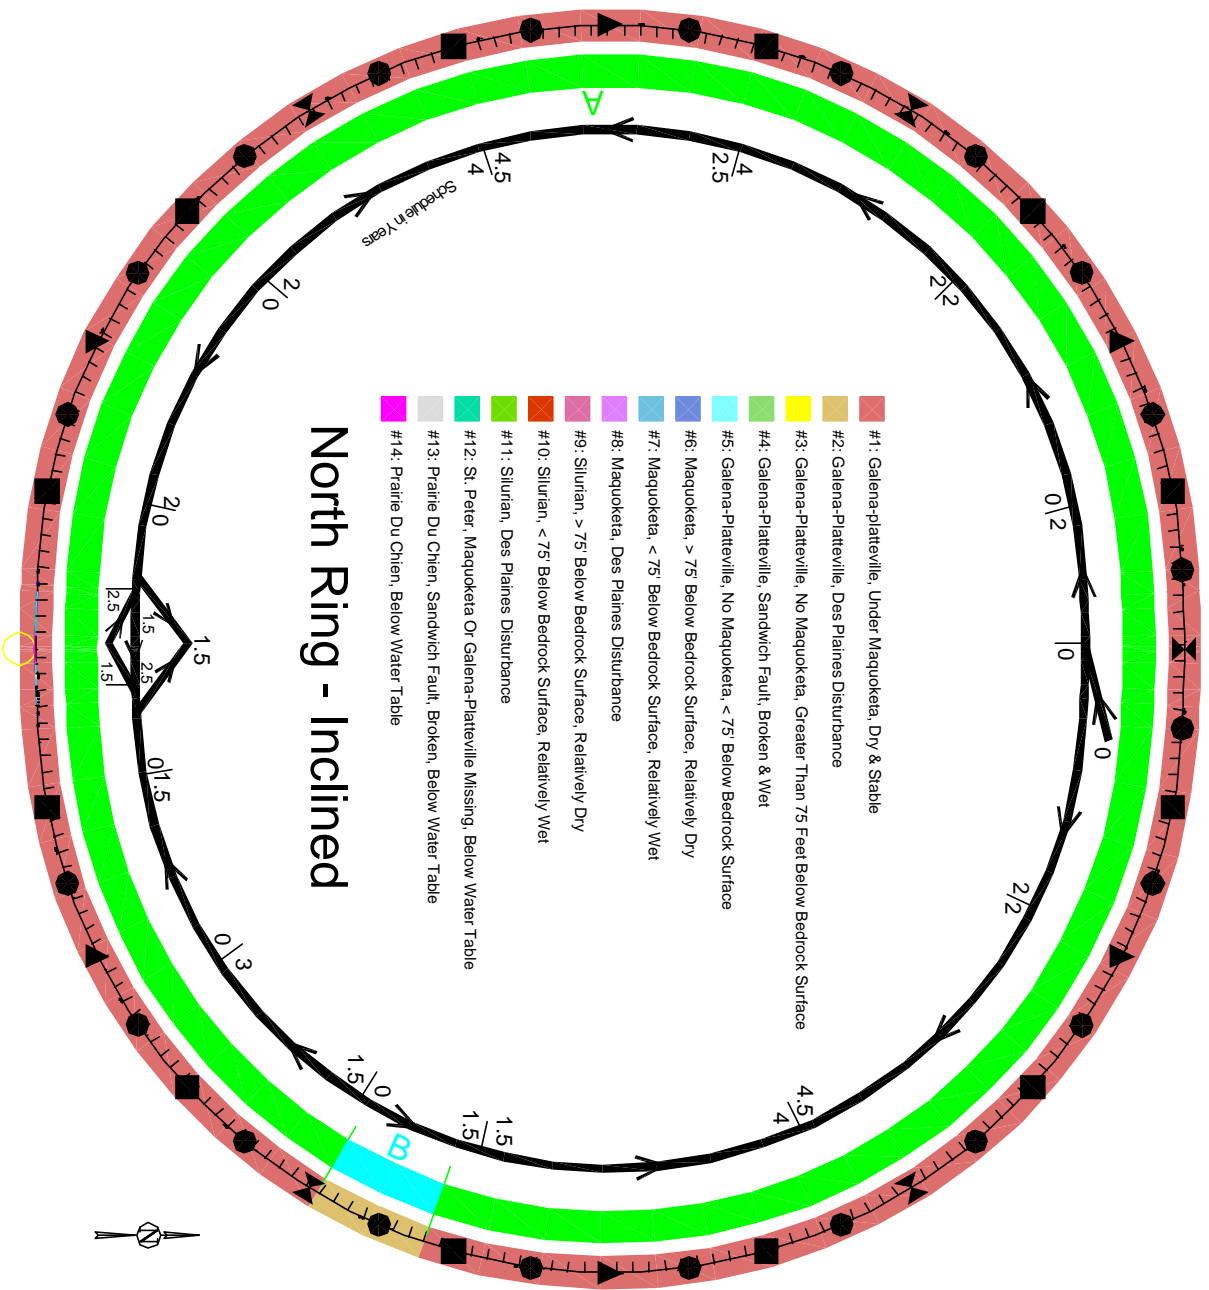
- #1: Galena-plateville, Under Maquoketa, Dry & Stable
- #2: Galena-Plateville, Des Plaines Disturbance
- #3: Galena-Plateville, No Maquoketa, Greater Than 75 Feet Below Bedrock Surface
- #4: Galena-Plateville, Sandwich Fault, Broken & Wet
- #5: Galena-Plateville, No Maquoketa, < 75 Below Bedrock Surface
- #6: Maquoketa, > 75 Below Bedrock Surface, Relatively Dry
- #7: Maquoketa, < 75 Below Bedrock Surface, Relatively Wet
- #8: Maquoketa, Des Plaines Disturbance
- #9: Silurian, > 75 Below Bedrock Surface, Relatively Dry
- #10: Silurian, < 75 Below Bedrock Surface, Relatively Wet
- #11: Silurian, Des Plaines Disturbance
- #12: St. Peter, Maquoketa Or Galena-Plateville Missing, Below Water Table
- #13: Prairie Du Chien, Sandwich Fault, Broken, Below Water Table
- #14: Prairie Du Chien, Below Water Table

- ▲ A Site
- ▲ B Site
- Mid Site
- ◆ Other EVN Site

- TBM A
UNSHIELDED TBM, LIMITED SUPPORT, LINING & GROUTING
- TBM B
OPEN TBM WITH FINGER SHIELD, ROCKBOLTS, MESH AND/OR RING BEAMS, WITH CAST IN PLACE CONCRETE LINER, WITH OR WITHOUT MEMBRANE, GROUTING
- TBM C
SEALED TBM WITH BOLTED & GASKETED CONCRETE LINER
