South Ring - Inclined

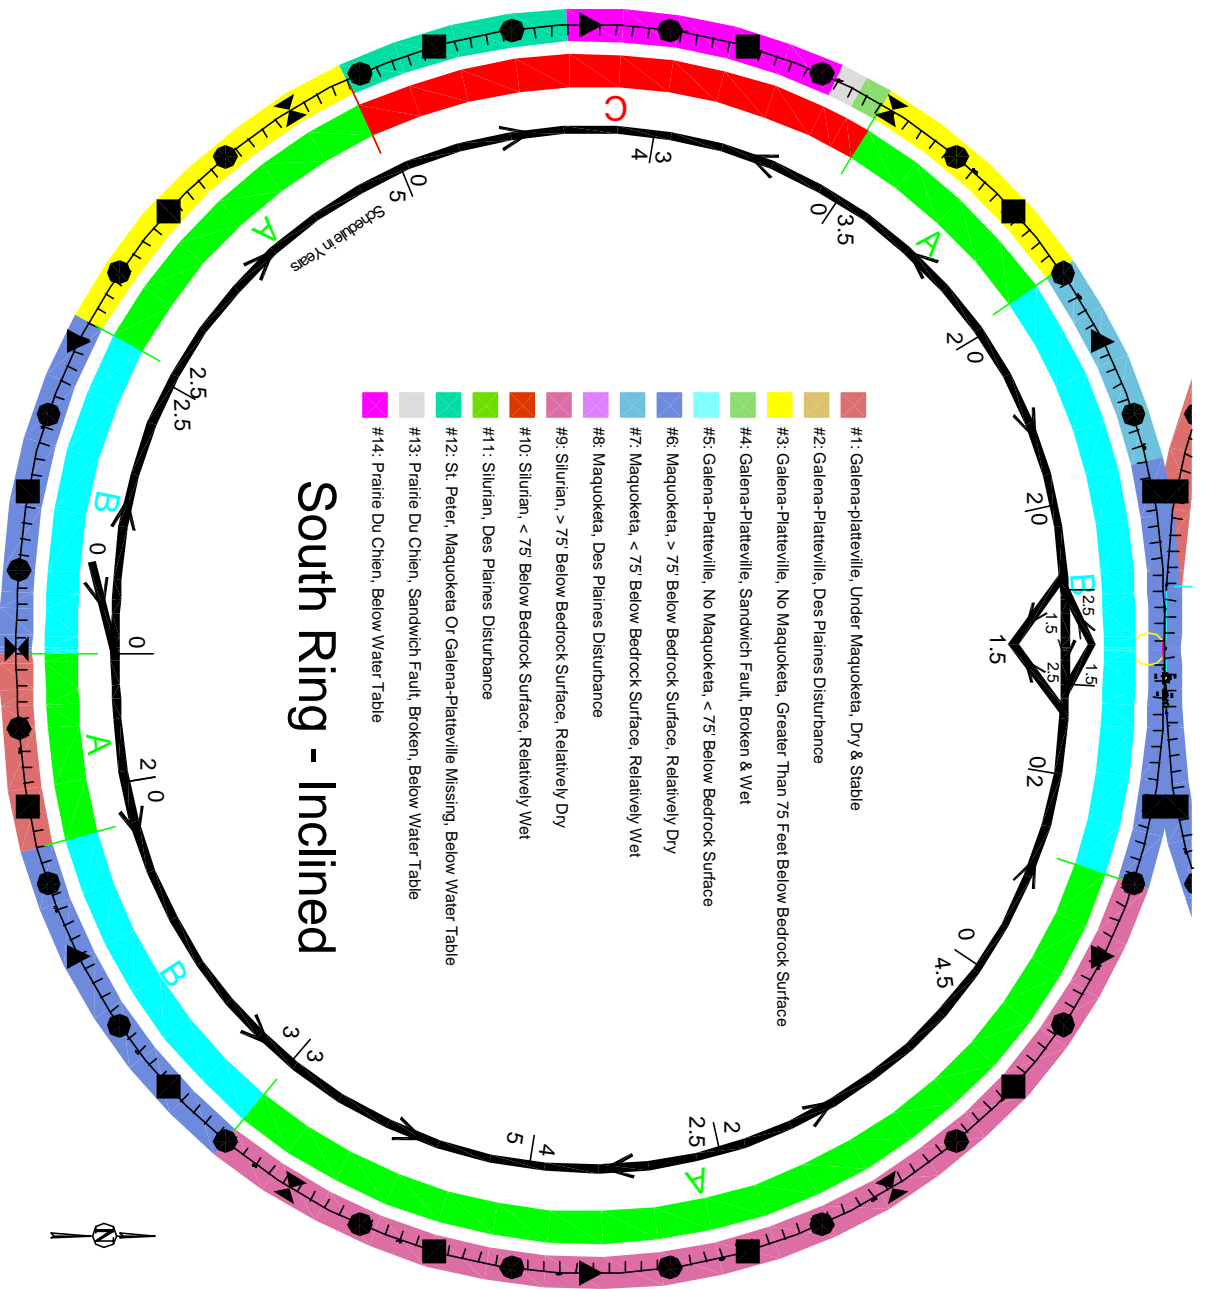
- #1: Galena-platteville, Under Maquoketa, Dry & Stable
- #2: Galena-Platteville, Des Plaines Disturbance
- #3: Galena-Platteville, No Maquoketa, Greater Than 75 Feet Below Bedrock Surface
- #4: Galena-Platteville, Sandwich Fault, Broken & Wet
- #5: Galena-Platteville, No Maquoketa, < 75' Below Bedrock Surface
- #6: Maquoketa, > 75' Below Bedrock Surface, Relatively Dry
- #7: Maquoketa, < 75' Below Bedrock Surface, Relatively Wet
- #8: Maquoketa, Des Plaines Disturbance
- #9: Silurian, > 75' Below Bedrock Surface, Relatively Dry
- #10: Silurian, < 75' Below Bedrock Surface, Relatively Wet
- #11: Silurian, Des Plaines Disturbance
- #12: St. Peter, Maquoketa Or Galena-Platteville Missing, Below Water Table
- #13: Prairie Du Chien, Sandwich Fault, Broken, Below Water Table
- #14: Prairie Du Chien, Below Water Table

- TBM A
UNSHIELDED TBM, LIMITED SUPPORT, LINING & GROUTING
- TBM B
OPEN TBM WITH FINGER SHIELD, ROCKBOLTS, MESH AND/OR RING BEAMS, WITH CAST IN PLACE CONCRETE LINER, WITH OR WITHOUT MEMBRANE, GROUTING
- TBM C
SEALED TBM WITH BOLTED & GASKETED CONCRETE LINER

- ▲ A Site
- ▲ B Site
- Mid Site
- Other E/V Site
