# North Ring - Flat

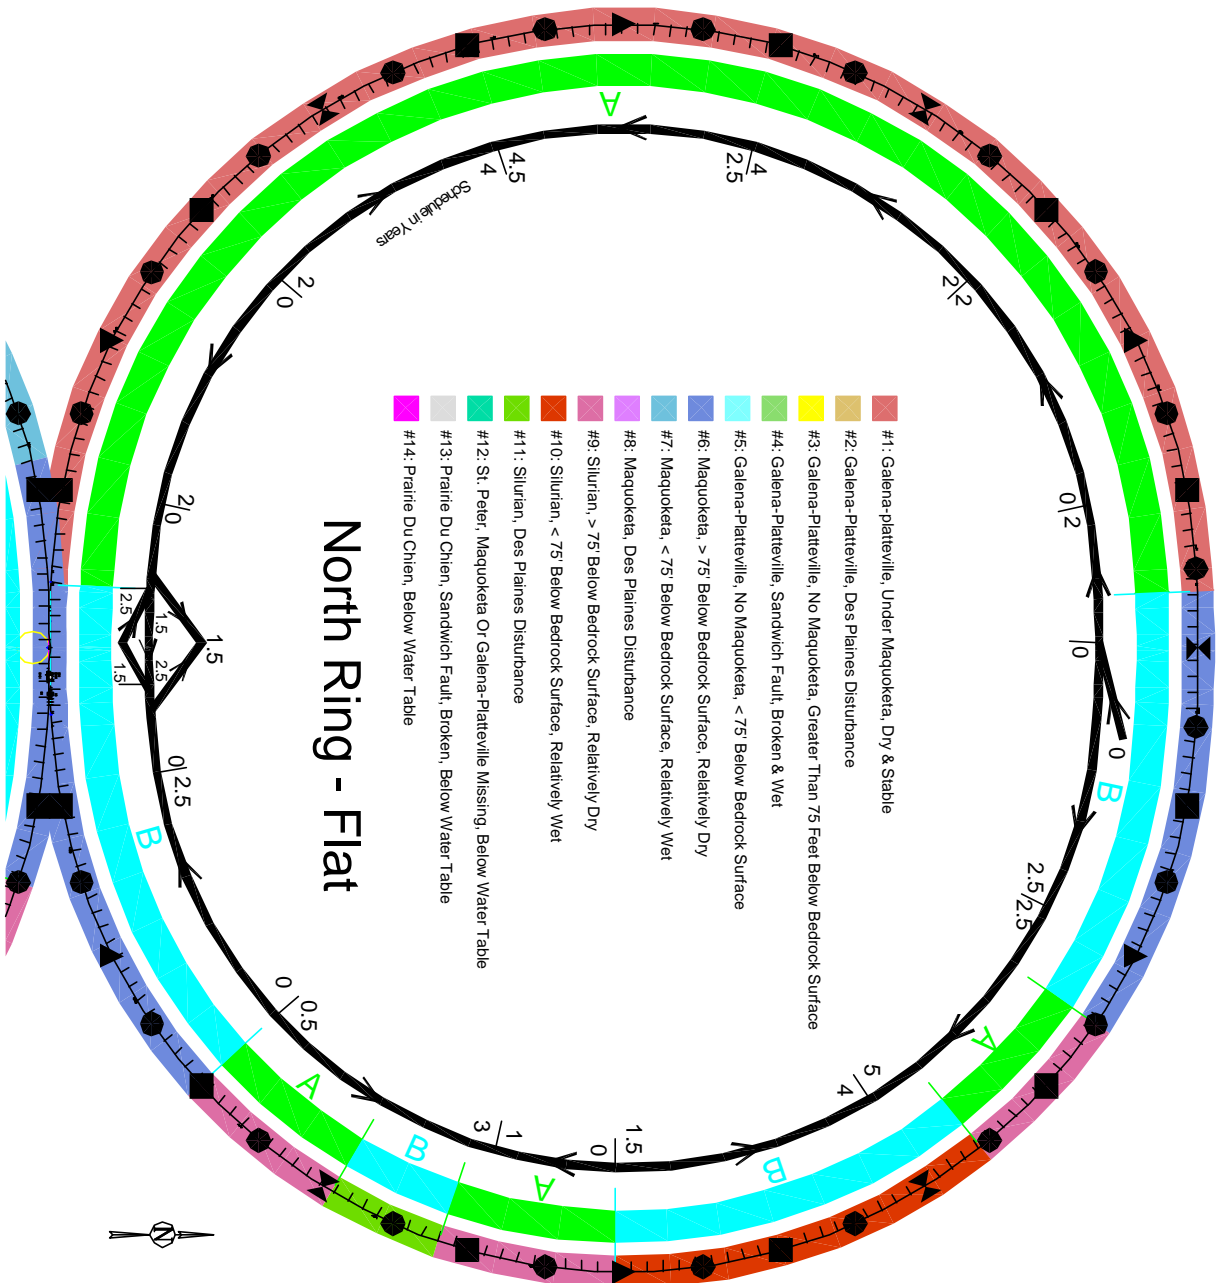
- #1: Galena-platteville, Under Maquoketa, Dry & Stable
- #2: Galena-Platteville, Des Plaines Disturbance
- #3: Galena-Platteville, No Maquoketa, Greater Than 75 Feet Below Bedrock Surface
- #4: Galena-Platteville, Sandwich Fault, Broken & Wet
- #5: Galena-Platteville, No Maquoketa, < 75' Below Bedrock Surface
- #6: Maquoketa, > 75' Below Bedrock Surface, Relatively Dry
- #7: Maquoketa, < 75' Below Bedrock Surface, Relatively Wet
- #8: Maquoketa, Des Plaines Disturbance
- #9: Silurian, > 75' Below Bedrock Surface, Relatively Dry
- #10: Silurian, < 75' Below Bedrock Surface, Relatively Wet
- #11: Silurian, Des Plaines Disturbance
- #12: St. Peter, Maquoketa Or Galena-Platteville Missing, Below Water Table
- #13: Prairie Du Chien, Sandwich Fault, Broken, Below Water Table
- #14: Prairie Du Chien, Below Water Table

- TBM A  
UNSHIELDED TBM, LIMITED SUPPORT, LINING & GROUTING
- TBM B  
OPEN TBM WITH FINGER SHIELD, ROCKBOLTS, MESS AND/OR RING BEAMS, WITH CAST IN PLACE CONCRETE LINER, WITH OR WITHOUT MEMBRANE, GROUTING
- TBM C  
SEALED TBM WITH BOLTED GASKETED CONCRETE LIN
- ▲ A Site
- ▲ B Site
- Mid Site
- Other EVV Site
